**Flood Control Project Maintenance
Levee Inspections**

Maintenance Issue Types Only, Levee Inspection Report By Mile - Fall 2015

Reclamation District No. 2058 Pescadero

Waterway	Bank	Unit Miles	Inspection Start/End	Inspector
Unit No. 01 Paradise Cut	Left	6.58	10/27/2015 10/27/2015	Maksim Khashchuk

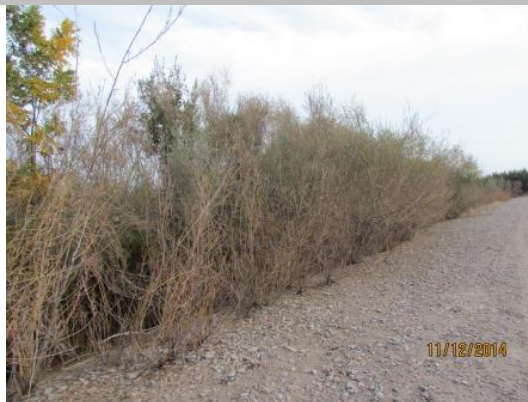
Photo 1 of 1 : FA_2015_RD2058_111_961_20150910_00020.jpg

LM Start	1.70	Rating **	A/W	Issue No.	961
LM End	1.76	Issue Type +	Ma	Location *	WS
Category	Earthen Levee			GPS Latitude/Longitude	
				Start	End
Item	Vegetation			37.804333 °	37.804615 °
				-121.393657 °	-121.392588 °
DWR ID	DWR_RD2058_01_s _ 2012_961				
Action/Comments					
Remove the wild growth other than native grasses from the levee slopes.					
Inspector Comments: LMA removed vegetation fall 2015.

View if the overgrown vegetation on the waterside slope to be removed.

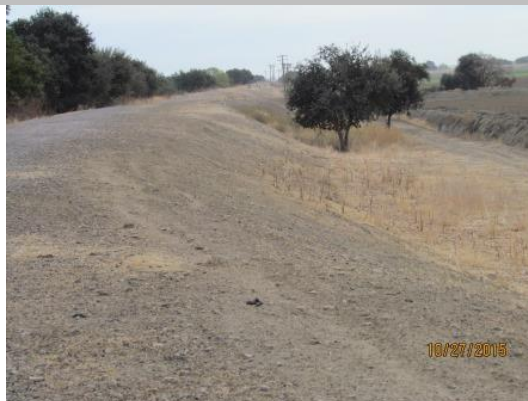
Photo 1 of 1 : FA_2015_RD2058_111_14_20151112_00025.jpg

LM Start	1.85	Rating **	A	Issue No.	14
LM End	1.85	Issue Type +	Ma	Location *	LS
Category	Earthen Levee			GPS Latitude/Longitude	
				Start	End
Item	Vegetation			37.804801 °	37.804801 °
				-121.390950 °	-121.390950 °
DWR ID	DWR_RD2058_01_f_2015_14				
Action/Comments					
Control annual grass and weeds on the levee slopes and easements.

View of the acceptable vegetation control on the landside levee slope.

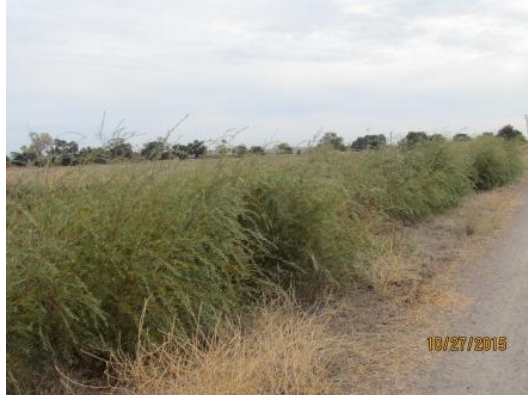
Photo 1 of 1 : FA_2015_RD2058_111_17_20151112_00026.jpg

LM Start	2.75	Rating **	A/W	Issue No.	17
LM End	2.75	Issue Type +	Ma	Location *	WS
Category	Earthen Levee			GPS Latitude/Longitude	
				Start	End
Item	Vegetation			37.801367 °	37.801367 °
				-121.375094 °	-121.375094 °
DWR ID	DWR_RD2058_01_f _ 2015_17				
Action/Comments					
Remove the wild growth other than native grasses from the levee slopes.					
Inspector Comments: LMA removed vegetation fall 2015.

View of the willows on the waterside levee slope.

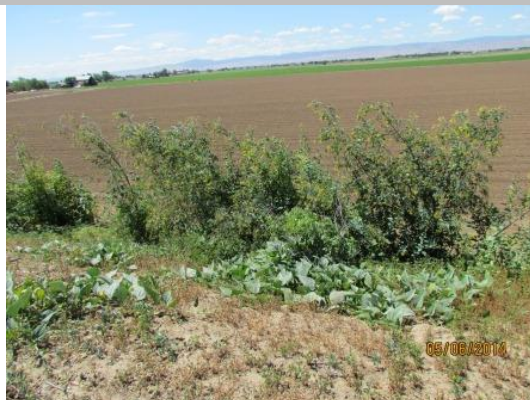
Photo 1 of 1 : FA_2015_RD2058_111_22_20150910_00009.jpg

LM Start	3.91	Rating **	A/W	Issue No.	22
LM End	3.91	Issue Type +	Ma	Location *	LS
Category	Earthen Levee			GPS Latitude/Longitude	
				Start	End
Item	Vegetation			37.789434 °	37.789434 °
				-121.361721 °	-121.361721 °
DWR ID	DWR_RD2058_01_s _ 2014_22				
Action/Comments					
Remove the wild growth other than native grasses from the levee slopes.					
Inspector Comments: LMA removed vegetation in Fall 2015.

View of the tall vegetation on the landside levee slope and toe.

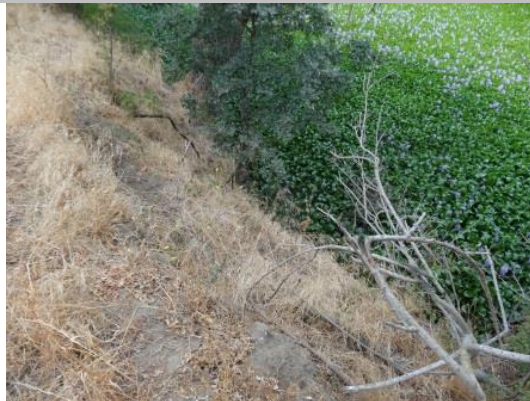
Photo 1 of 3 : SJR2015_RD2058U01RM3.97_13.jpg

Inspector Comments: 08/04/2015: No significant change observed.
 08/26/2014: No significant change observed.
 08/28/2013: No significant change observed.
 07/26/2012: The site has been visited, and no significant change has been observed.
 09/02/2011: This site was not visited due to the time limit.
 09/22/2010: No significant change observed. Minor pocket erosions are lined at the lower bank. Two large Oak and Willow trees are on mid-slope and bench. The remaining bench was re-measured and found to be approximately 10 feet. There was no indication of active erosion on site during the site visit.
 08/05/2010: Recommended for annual assessment and monitoring of the site during flood events, per CLRO.
 07/23/2009: No major change observed since last visit; site is a 200-ft. long near-vertical berm erosion; recommend annual assessment and monitoring of the erosion site, per CLRO CES Evaluation 2008 Report; Site # is the same site previously reported as RM4.0,LM4.51; previously rated "U".

09/10/2008: Two large trees (2-3' DBH) with partial roots exposed.
 2007: Visited site 03/13/2007. [2015 Site ID:RD2058U01RM3.97]

Direct view of the erosion near a tree.

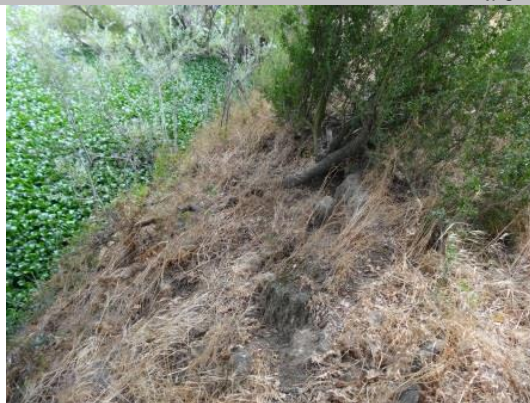
Photo 2 of 3 : SJR2015_RD2058U01RM3.97_2.jpg

Direct view of the erosion near a tree.

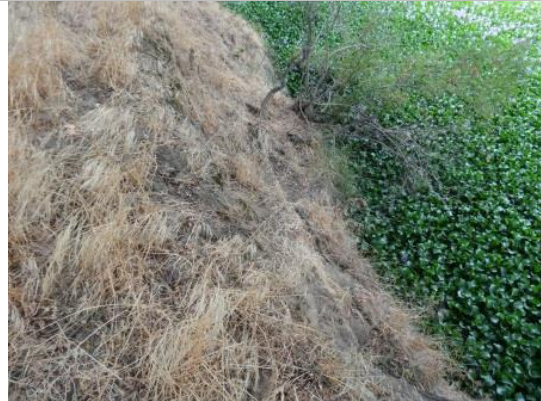
Photo 3 of 3 : SJR2015_RD2058U01RM3.97_5.jpg

Direct view of a pocket erosion site.

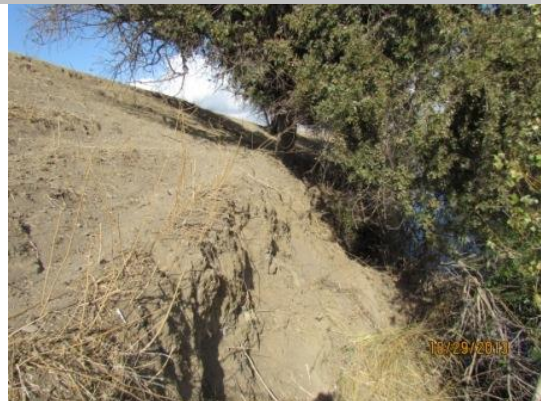
Photo 1 of 1 : FA_2015_RD2058_111_15_20150910_00006.jpg

LM Start	4.77	Rating **	U	Issue No.	15
LM End	4.77	Issue Type +	Ma	Location *	WS
Category	Earthen Levee			GPS Latitude/Longitude	
				Start	End
Item	Erosion / Bank Caving			37.785862 °	37.785862 °
				-121.350303 °	-121.350303 °
DWR ID	DWR_RD2058_01_f_2013_15				
Action/Comments					
Note and monitor erosion site. Inspector Comments: The erosion has about a 3 foot vertical cut at the waterside levee toe.

View of the erosion at the waterside levee toe.

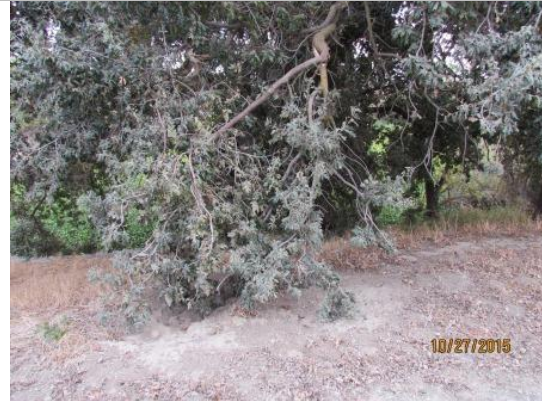
Photo 1 of 1 : FA_2015_RD2058_111_18_20151112_00027.jpg

LM Start	4.81	Rating **	A/W	Issue No.	18
LM End	4.81	Issue Type +	Ma	Location *	WS
Category	Earthen Levee			GPS Latitude/Longitude	
				Start	End
Item	Trim / Thin Trees			37.785265 °	37.785265 °
				-121.350060 °	-121.350060 °
DWR ID	DWR_RD2058_01_f _ 2015_18				
Action/Comments					
Trim trees to at least five feet above ground level.					
Inspector Comments: LMA trimmed the tree fall 2015.

View of the branch touching the waterside levee slope.
